Nature-like Fishways

RECONNECTING RIVERS

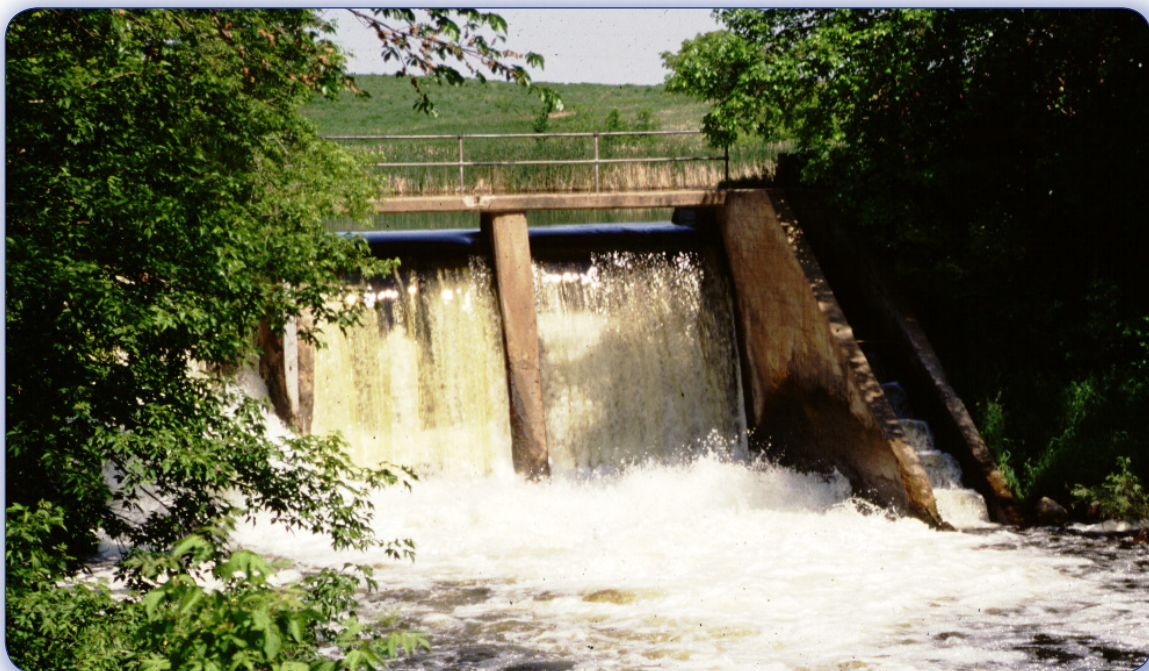
Figure 49. Traditional fish ladder built in 1929 on the Pelican River in west-central Minnesota. Lake sturgeon exceeding 100 pounds historically were found in this watershed and likely migrated past this site prior to construction of the dam. This fish ladder is not effective for any of the native species.

Traditional approaches to fish passage involved the use of concrete baffles and compartments. Some of these designs required the fish to jump from one compartment to the next posing a problem for fish species that don't tend to jump. In other cases, the compartments are so small and the slope so steep that it is unlikely that any fish species is able to consistently pass them (Figure 49).

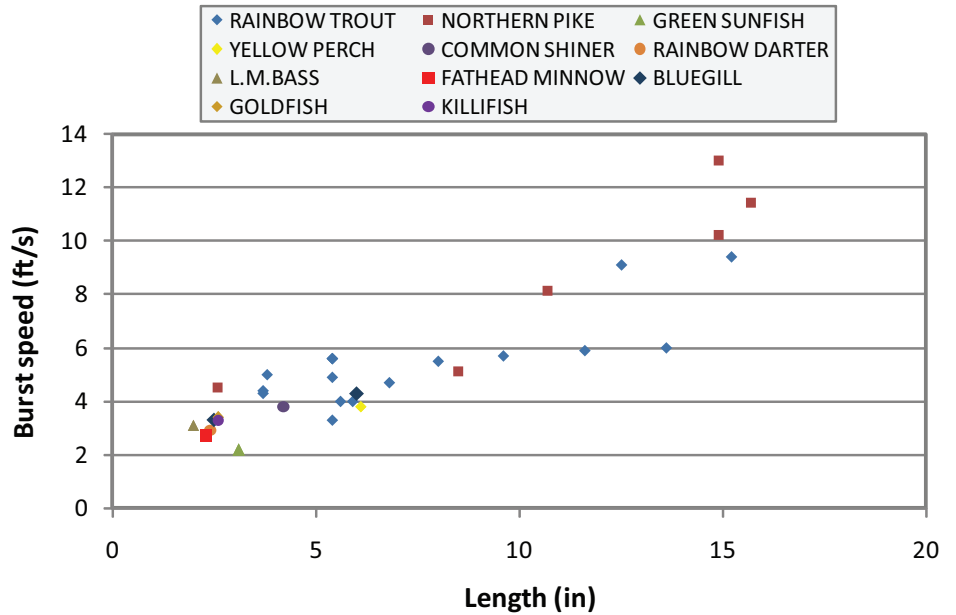
Figure 50. Burst swimming speeds of rainbow trout and some warm and cool water fishes (data from Domenici and Blake 1997).

Many of our native warm and cool water fish species have comparable burst swimming speeds to that of the salmonids (Figure 50) but are generally less effective in passing barriers. Northern pike *Esox lucius* have high burst speeds as a result of their elongate sagittiform shape but lack maneuverability for the same reason and have difficulty with barriers that other species can pass.

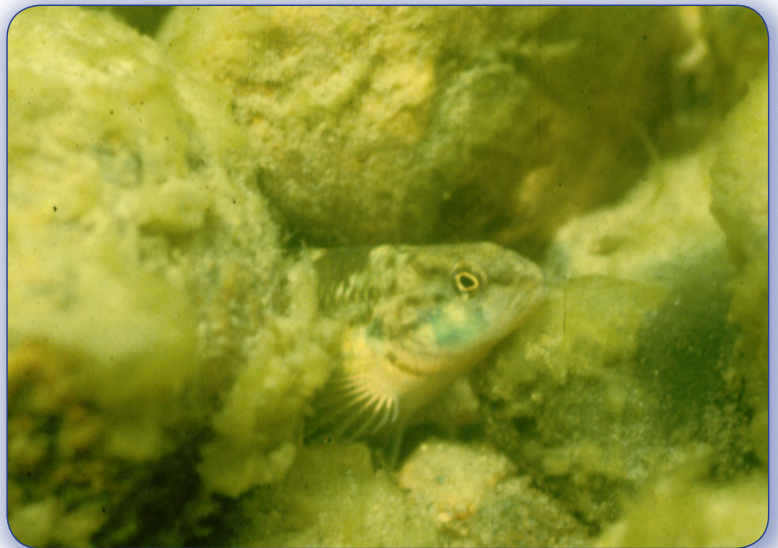
Figure 51. A rainbow darter *Etheostoma caeruleum* using interstitial space in gravel. This species prefers mean column velocities near its maximum burst speed.

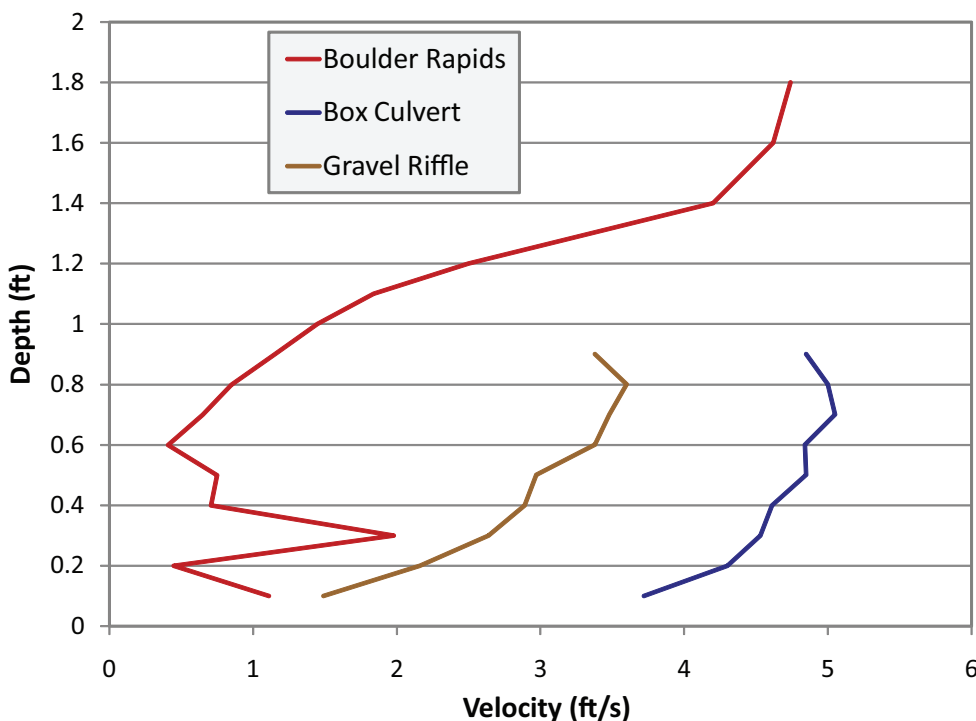
Figure 52. Velocity profiles over three different substrate types in the Otter Tail River. The rock rapids profile was from a constructed fishway.

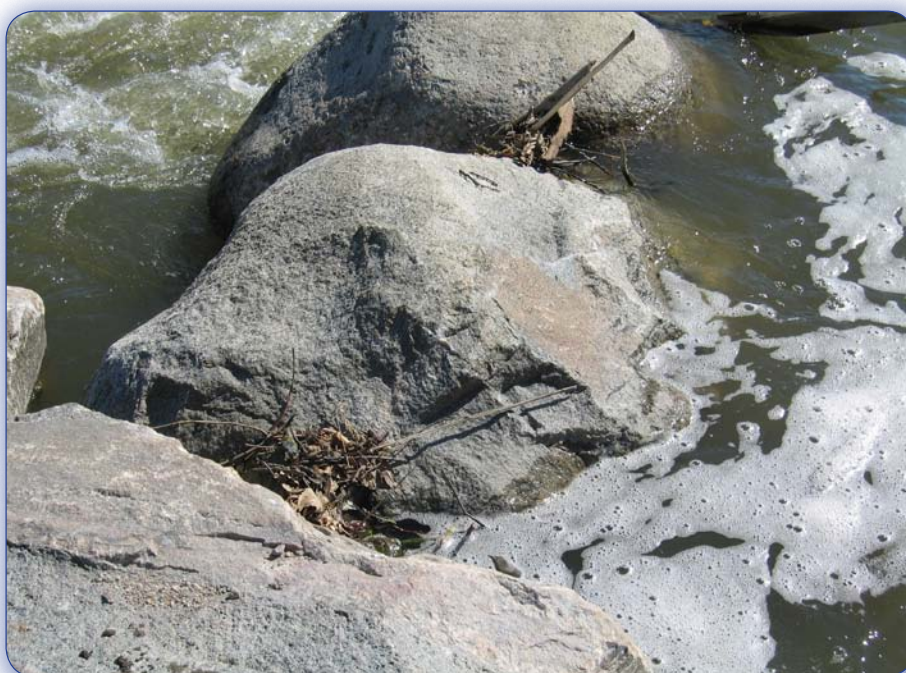
Figure 55. Leaves and woody debris sealing void in a rock rapids fishway.

3) Large amounts of organic matter including leaves, wood, and aquatic plants are annually carried by rivers, especially in the fall. These materials are drawn into voids where subsurface flows enter the rock base (Figure 55). Subsequent fine sediments collect on these organics and further plug subsurface flow.

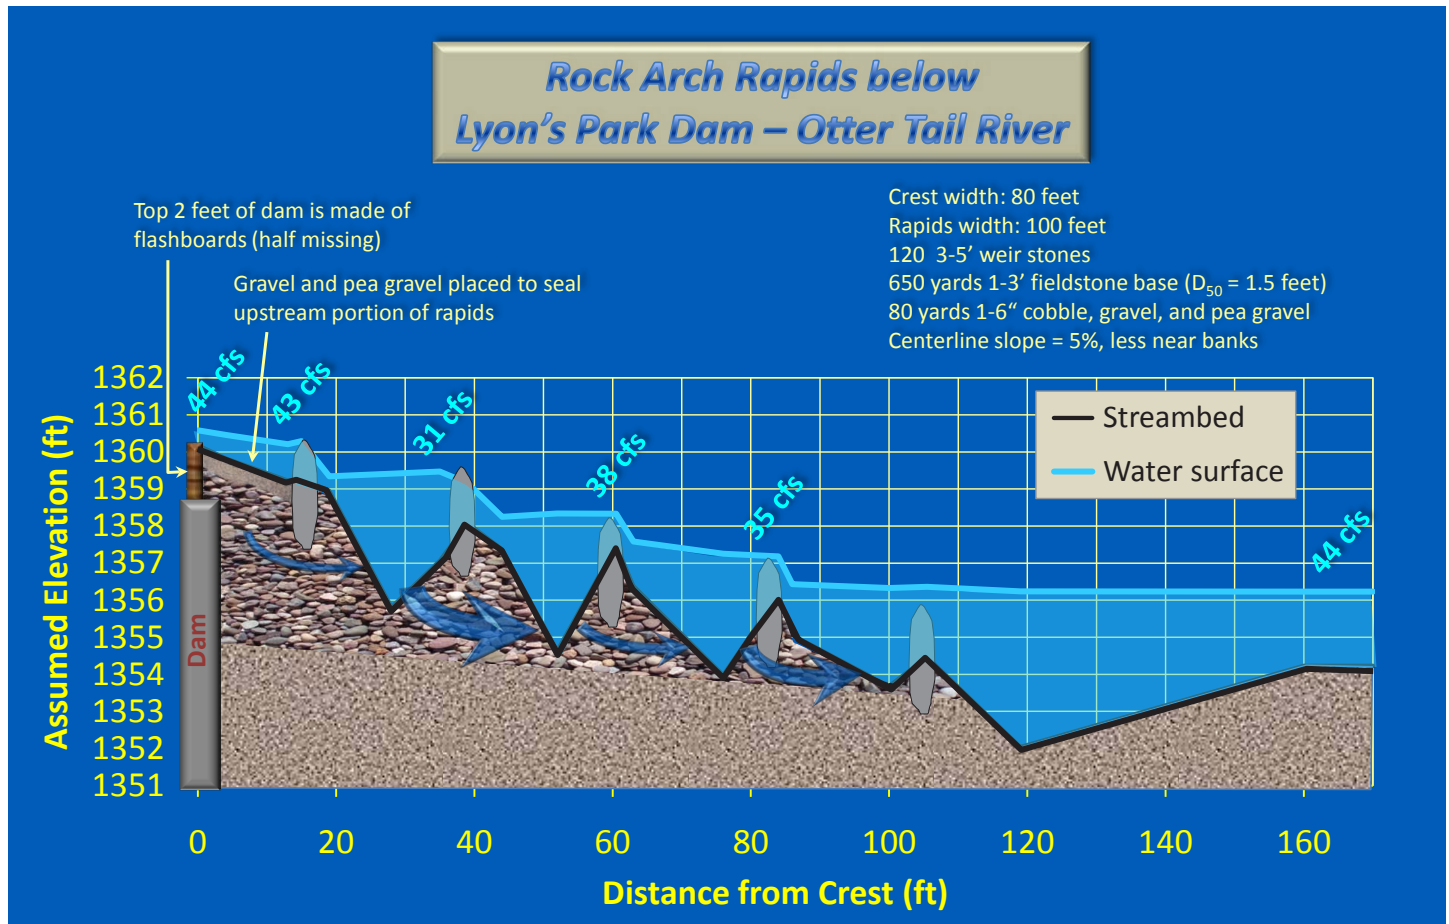
Figure 56. Centerline profile and surface discharge measurements in Lyon's Park Dam Rock Arch Rapids. Discharge measurements were taken at 4, 13, 35, 60, 85, and 170 feet downstream of crest.

between the dam crest and the first weir were sealed with gravel and pea gravel but the remainder of the ramp was not. A discharge measurement was taken at a riffle downstream of the rock ramp to establish full-river flows. The difference between the full-river flow and surface measurements taken on the rock ramp indicated subsurface flows at the corresponding cross-section (Figure 56). These measurements showed very little leakage in the upstream portion of the rapids where the rapids was sealed with gravel and the measurement taken four feet downstream of the crest matched full river flow while the difference between full river flow and a measurement 13 feet downstream of the crest was less than one cubic foot per seconds (cfs). The greatest leakage was 35 feet downstream of the crest where surface flows were 13 cfs less than full river flows.

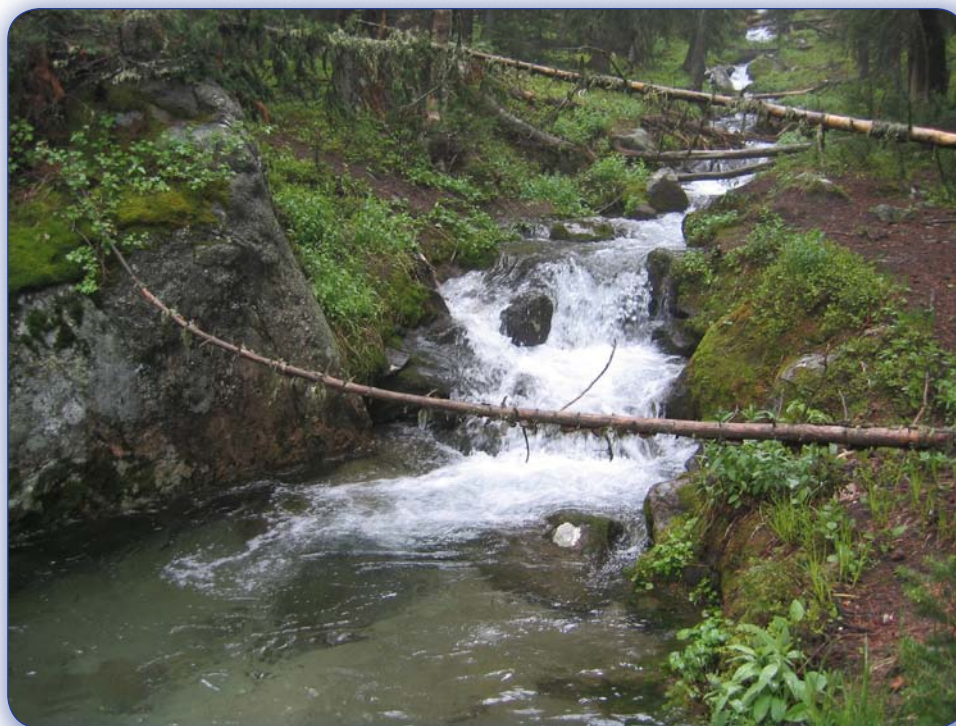
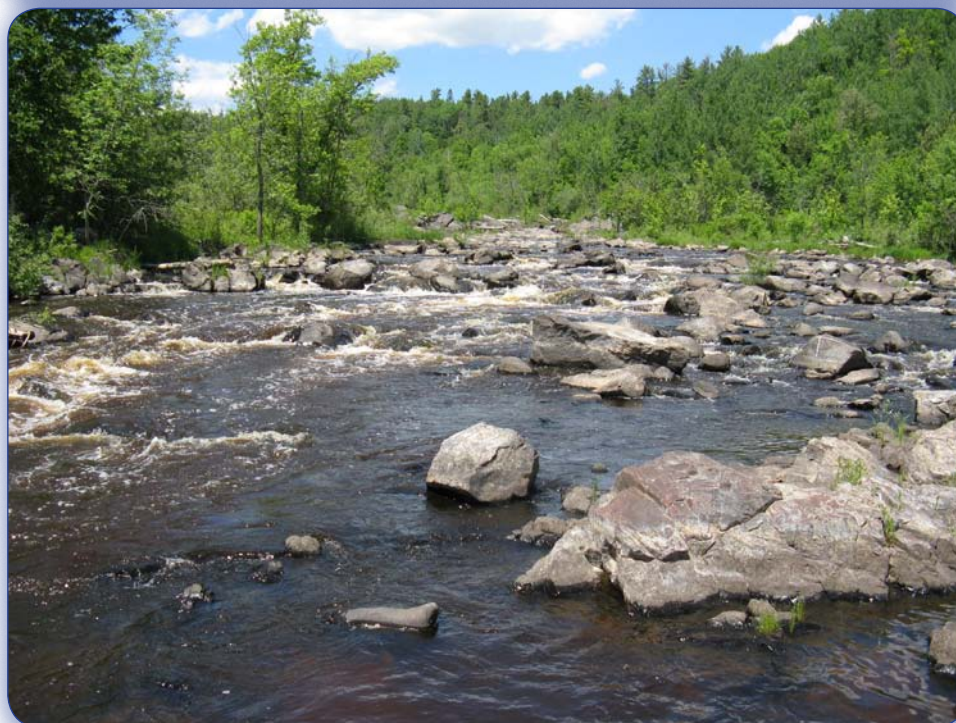
Figure 58. Hellroaring Creek, Montana, a steep, natural stream with a step-pool channel and the St. Louis River, Minnesota showing a large step-pool rapids.

Steep (> 2%) natural channels tend to have a step-pool configuration (Figure 58). The pools provide

resting habitat and areas that allow fish to position their bodies to launch through the step. Step spacing in these channels is often closer, 0.43 to 2.4 channel widths (Chin 2002) than riffle spacing found in low gradient streams of five to seven channel widths (Leopold et al. 1964).

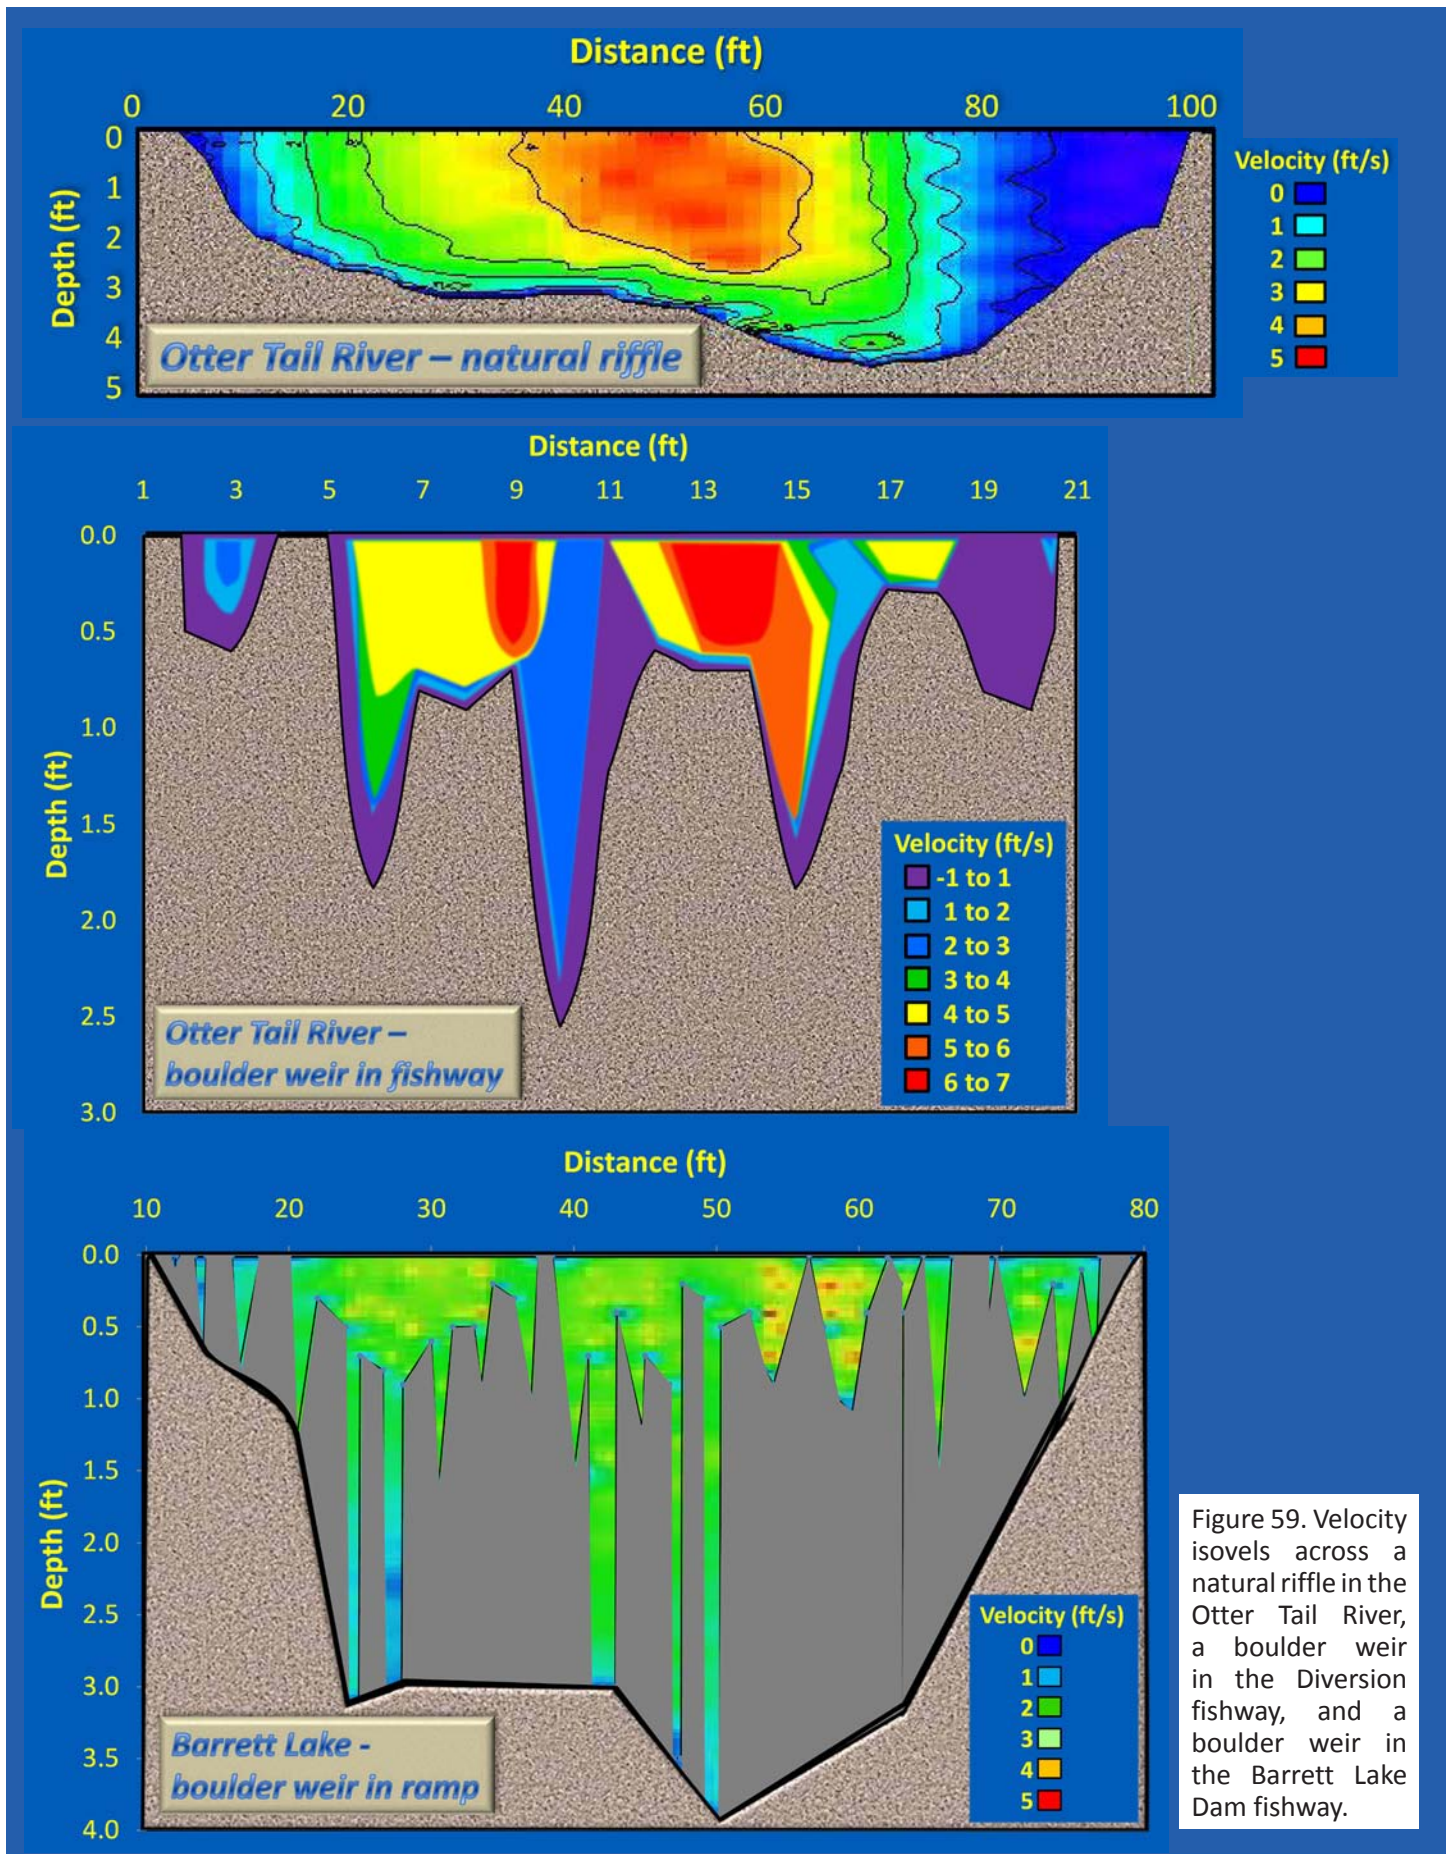
Figure 59. Velocity isovels across a natural riffle in the Otter Tail River, a boulder weir in the Diversion fishway, and a boulder weir in the Barrett Lake Dam fishway.

diverse velocity distributions similar to natural riffles. Use of an elliptical cross-section and variable gaps between boulders provides a wide range of depths and velocities. Figure 59 demonstrates the complex velocity distributions of a natural riffle and two different boulder weirs in fishways. I have observed

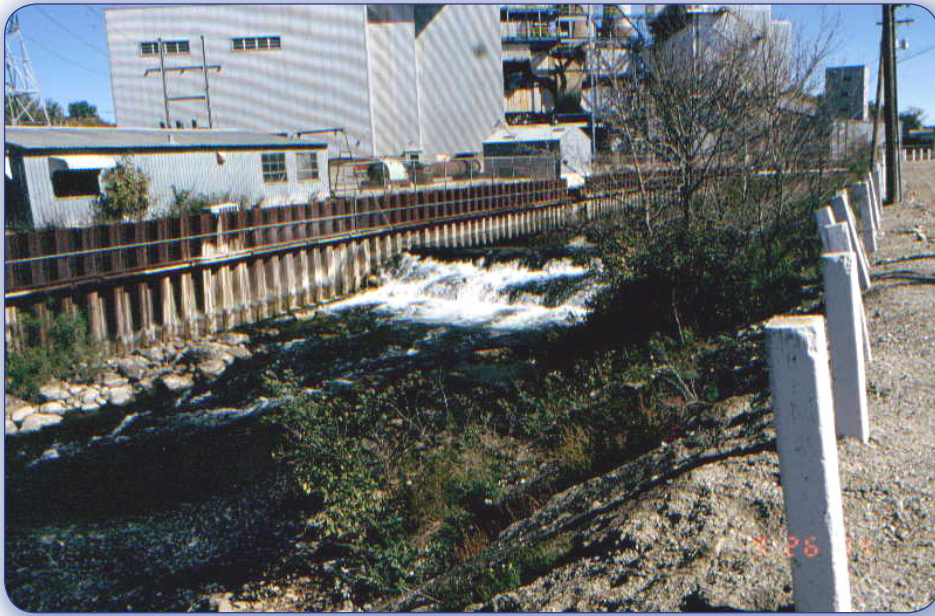
Figure 62. The Steam Plant Dam on the Otter Tail River. The dam was made of concrete and burlap bags filled with fly ash.

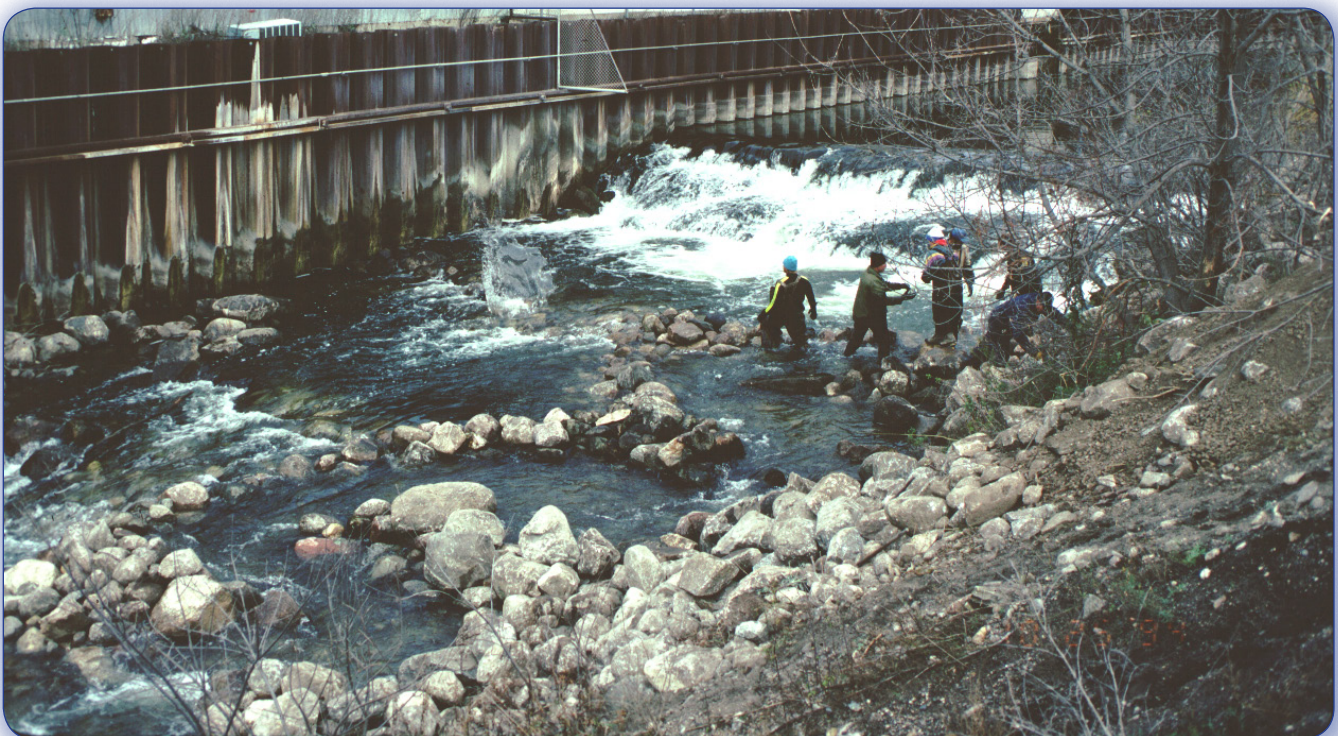
Figure 64. Hand placement of fieldstone during the initial conversion of the Steam Plant Dam to rapids, October, 1994.

Improvements used about 750 yards of fieldstone including about 80 three-foot plus stones. The rock cost was \$20 per yard or \$15,000 total. The work

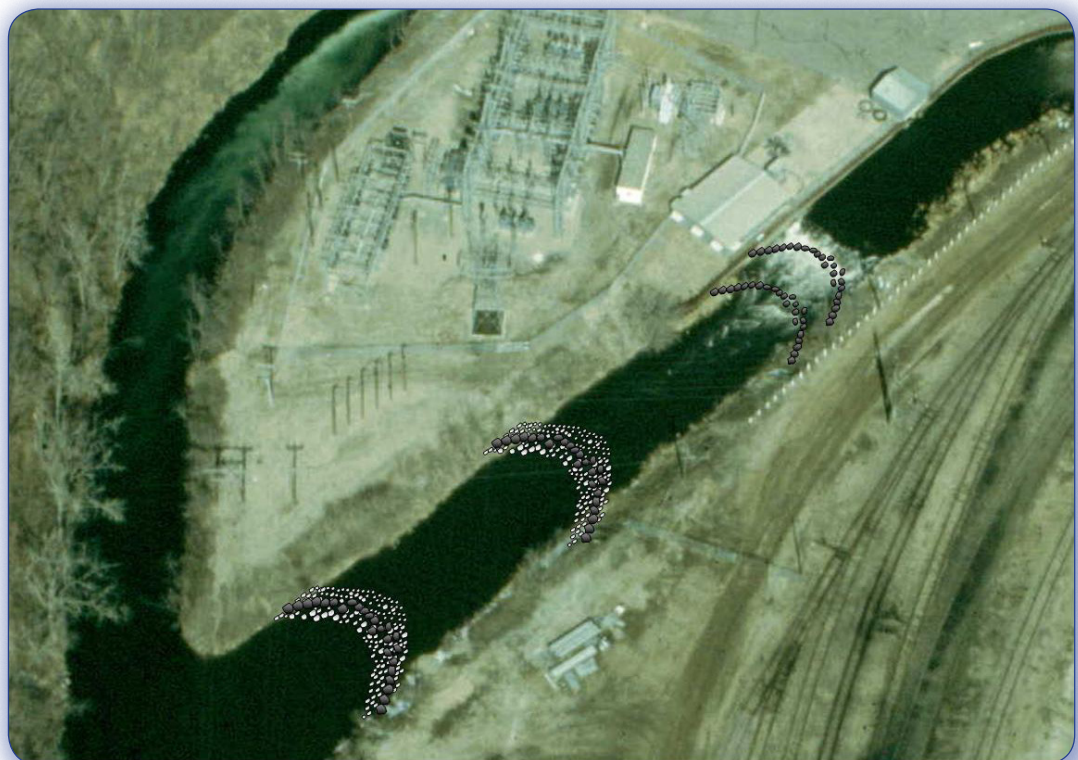
Figure 66. Planview for improvements to the Steam Plant Rapids.

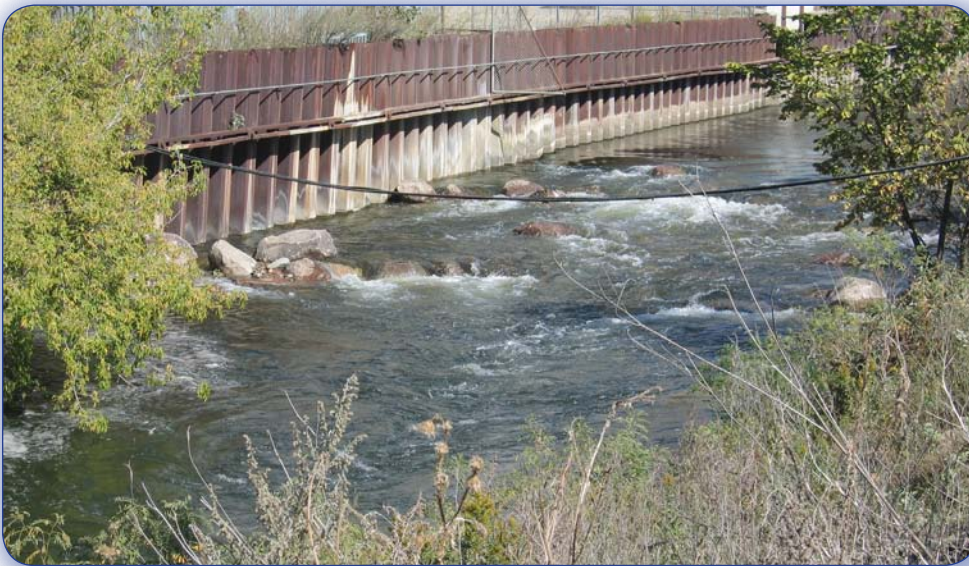
Figure 67. Plant Rapids after improvements in September, 2005.

Our experience with other projects and the development of the Rock Arch Rapids design prompted Fisheries and Trails and Waterways staff to pursue funding to improve the project. The improvement involved the addition of two boulder weirs on the existing rock and two downstream riffles that would reduce the overall slope to 1% and each step to about a foot of head-loss (Figures 66 - 69). The downstream placement of the riffles avoided the deep pool immediately downstream of the existing rapids that would have required much more fieldstone.

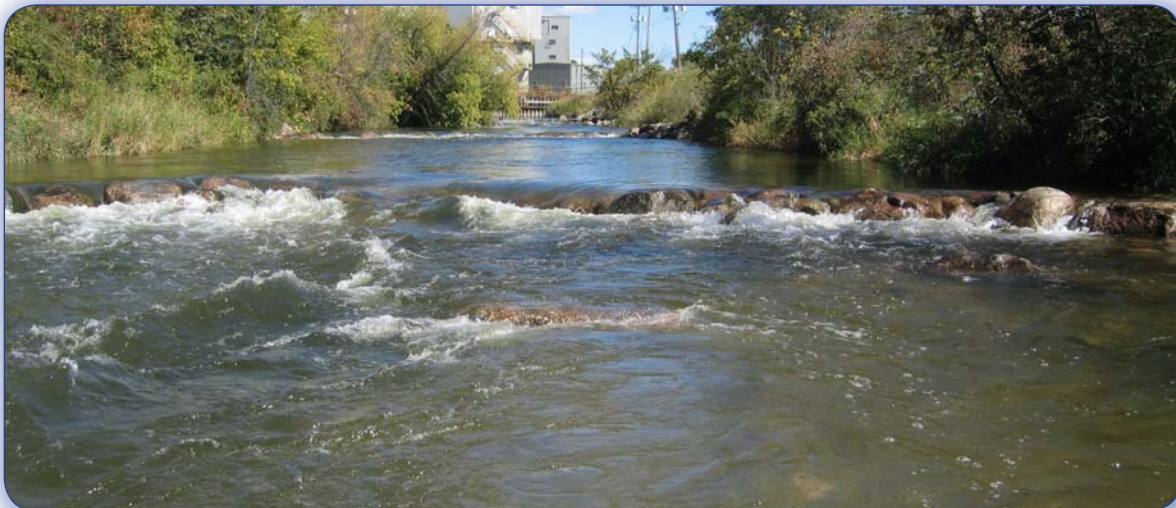
Figure 68. Steam plant rapids viewed from downstream showing the constructed riffles.

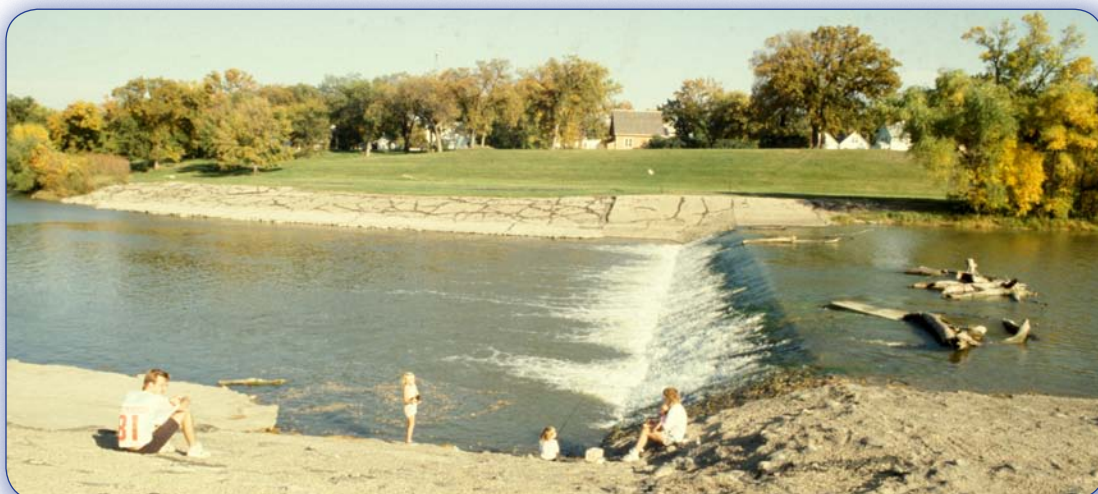
Figure 70. The Midtown Dam on the Red River of the North between Fargo, North Dakota and Moorhead, Minnesota (photo courtesy of Robert Backman, River Keepers).

Historical and Political Context: The U.S. Army Corps of Engineers, as part of a flood control project, originally built the Midtown Dam in 1961 when the channel was straightened and flood control levees were built (Figure 70). It replaced an earlier dam built in 1929. Between 1997 and its completion there were at least 19, and as many as 25, deaths by drowning at the site due to the hydraulic roller created by the dam crest.

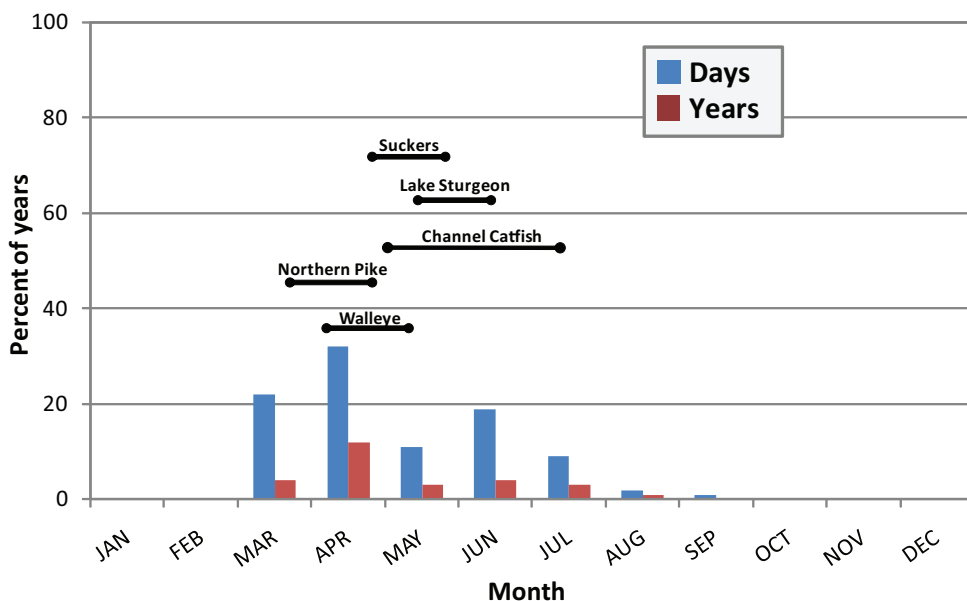
Figure 71. Percent of days and years that Midtown Dam was passable. Based on U.S.G.S gage 05054000 records from 1901 to 1997 and the assumption that the dam was passable at flows greater than 3000 cfs. Approximate migration periods are shown by lines for northern pike *Esox lucius*, walleye *Lucioperca vitrium*, suckers *Catostomus commersoni* and *Moxostoma sp.*, lake sturgeon *Acipenser fulvescens*, and channel catfish *Ictalurus punctatus*.

The dam was also a barrier to fish migration. The Red River of the North has a diverse fish assemblage with at least 57 species (Aadland et al 2005). One tagged channel catfish had been observed migrating over 300 miles, from Fargo to Lake Winnipeg (Hegrenes 1992). While the dam was submerged and passable during floods, they were of short duration, inconsistent, and did not necessarily coincide with spawning migrations (Figure 71).

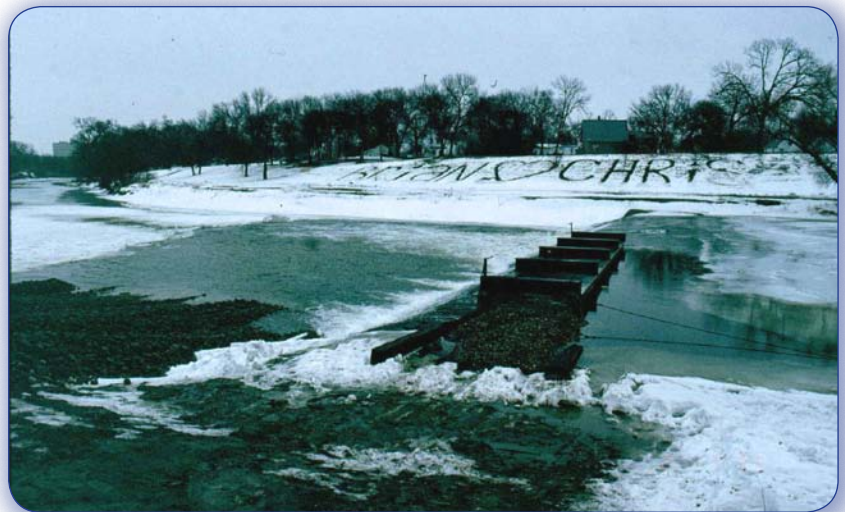
Figure 72. Temporary partial diversion using steel I-beams placed on the dam crest.

The bid was awarded to Industrial Builders, Incorporated of Fargo, North Dakota and construction began on February 9, 1998. Flows were partially diverted by placing a large double I-beam on the dam crest (Figure 72). This created slack water so small diameter sub-base could be placed.

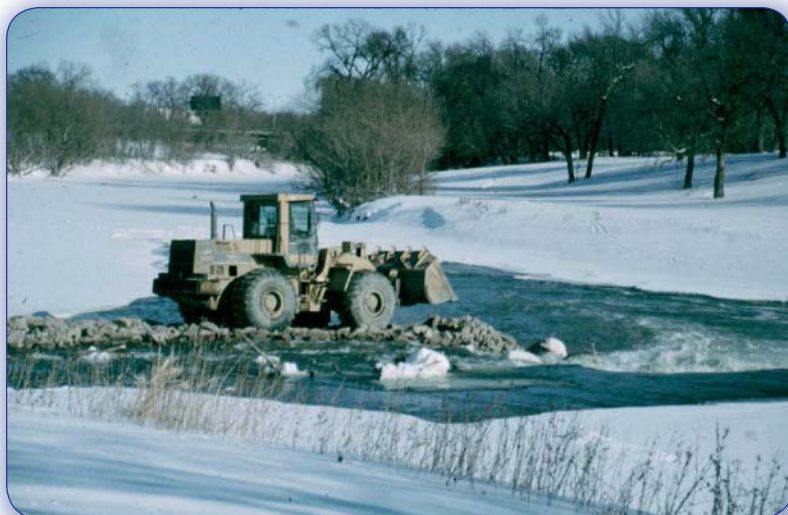
Figure 73. A front-end loader using the rock causeway to supply fieldstone for placement by the excavator.

However, even with this diversion, placement of the 1.25" and smaller crushed rock was difficult as material was lost where velocities increased near the center of the river, therefore larger crushed rock was substituted. As the center of the channel was approached, the larger base material was used exclusively since velocities were too high for placement of the smaller material (Figure 73). Work had to be suspended on February 24, and the I-beam

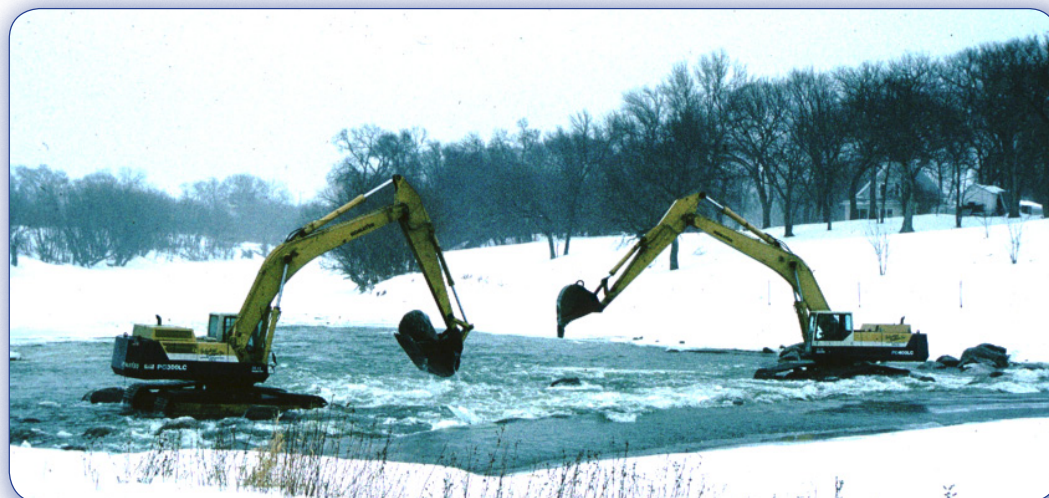
Figure 74. Two excavators using a bucket-brigade technique for placing weir stones.

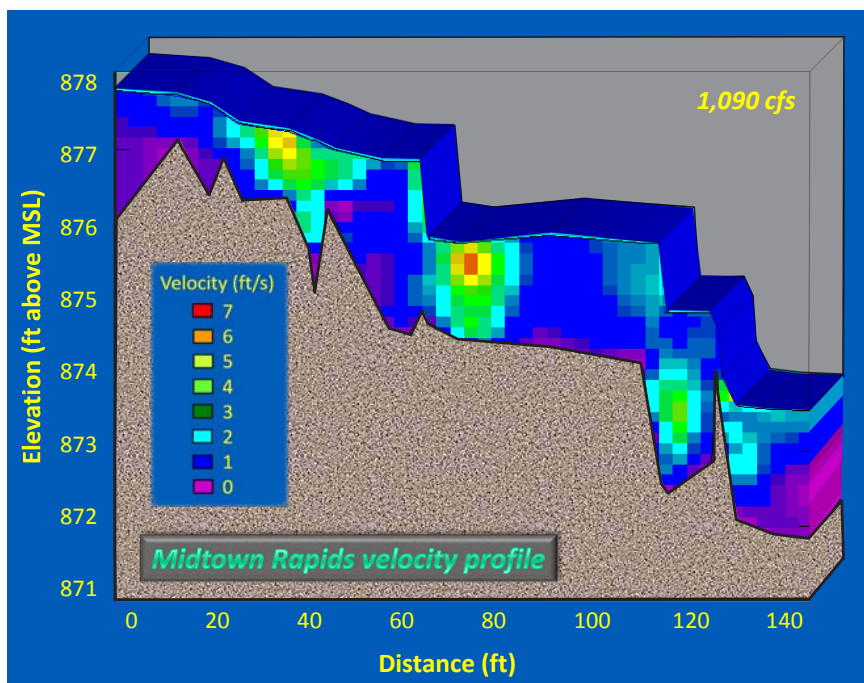
Figure 76. Longitudinal velocity distribution taken on August 3, 1999 at a flow of 1,090 cfs. This does not necessarily represent the best route for a migrating fish but is intended to show the velocity gradients one would encounter.

velocities between weirs and higher velocities in and directly downstream of the gap between boulders in the weirs. Velocities of up to 6.5 feet per second were measured at points directly downstream of the weirs but even at these locations, velocities near the substrates remained significantly lower (generally four feet per second or lower, Figure 76).

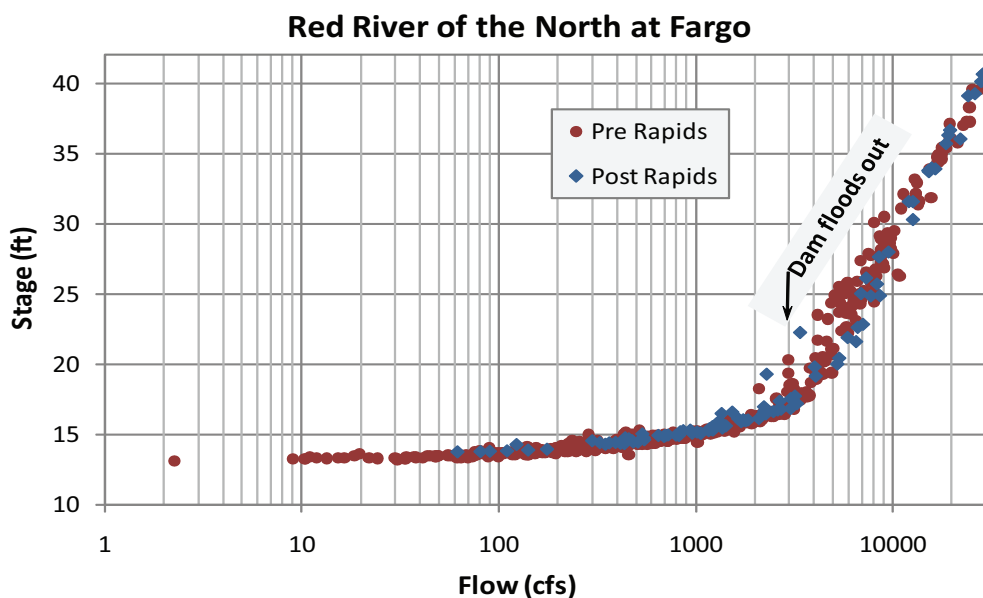
Figure 77. Stage and discharge measurements made by the U.S. Geological Survey at the gage (05054000) upstream of Midtown Dam before and after it was converted to rapids.

While it is logical that increased roughness of the weir and reduced cross-sectional area due to boulders placed on the crest would cause increased resistance and higher stage, these effects were apparently too small to be apparent at low flows and are compensated by elimination of the hydraulic roller and submergence at high flows. These empirical data were supported by numerical models done at the Waterways Experiment Station in Vicksburg, Mississippi that predicted no increases in upstream stage of the 100-year event resulting from a similar proposed project at the Fargo South Dam (Fuller and Bernard 2000). Record flows during the 1997 flood were 28,000 cfs at the site and had

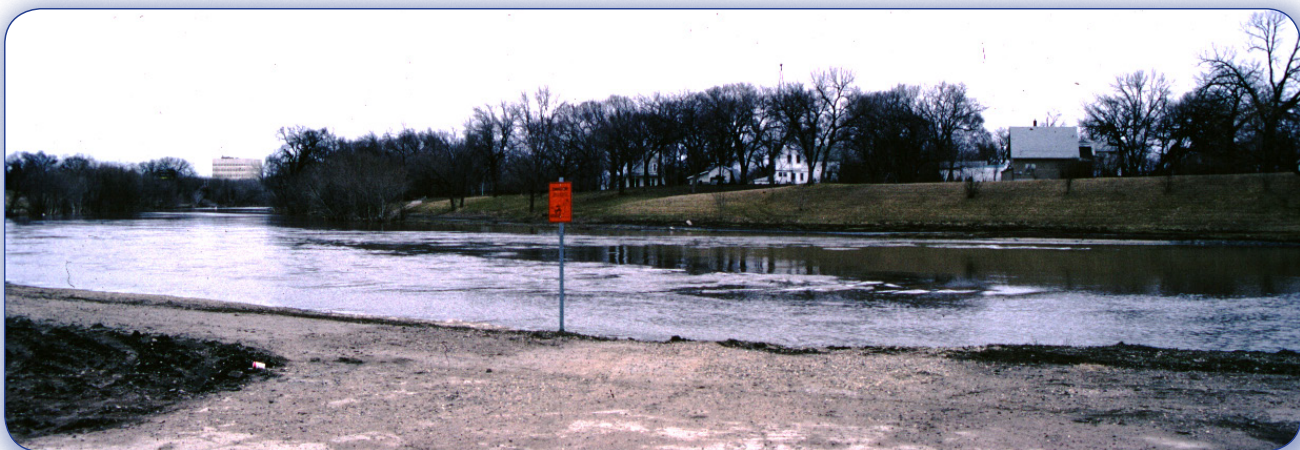
Figure 78. Midtown Rapids at a flow of 3,430 cfs on April 4, 1999 showing minimal head-loss over the structure.

a stage of 901.52 or 25.82 feet above the Midtown Dam crest. The 100-year flood is presently calculated at 31,400 cfs. Observed head-loss over the dam and rapids is minimal (less than a tenth of a foot) at flows above 3,000 cfs (Figure 78).

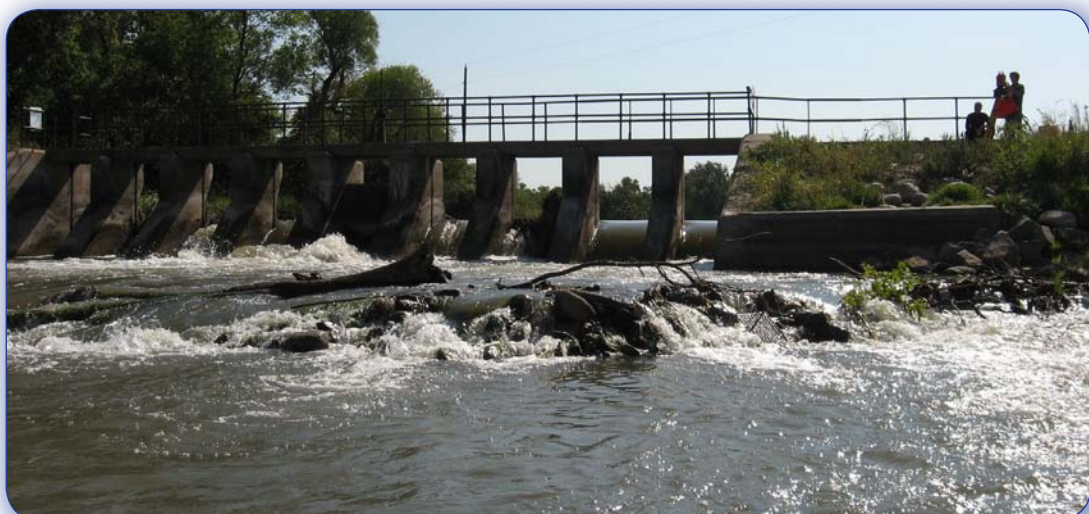
Figure 80. Breckenridge Dam on the Otter Tail River in West Central Minnesota. Stop-logs are not installed in this photo.

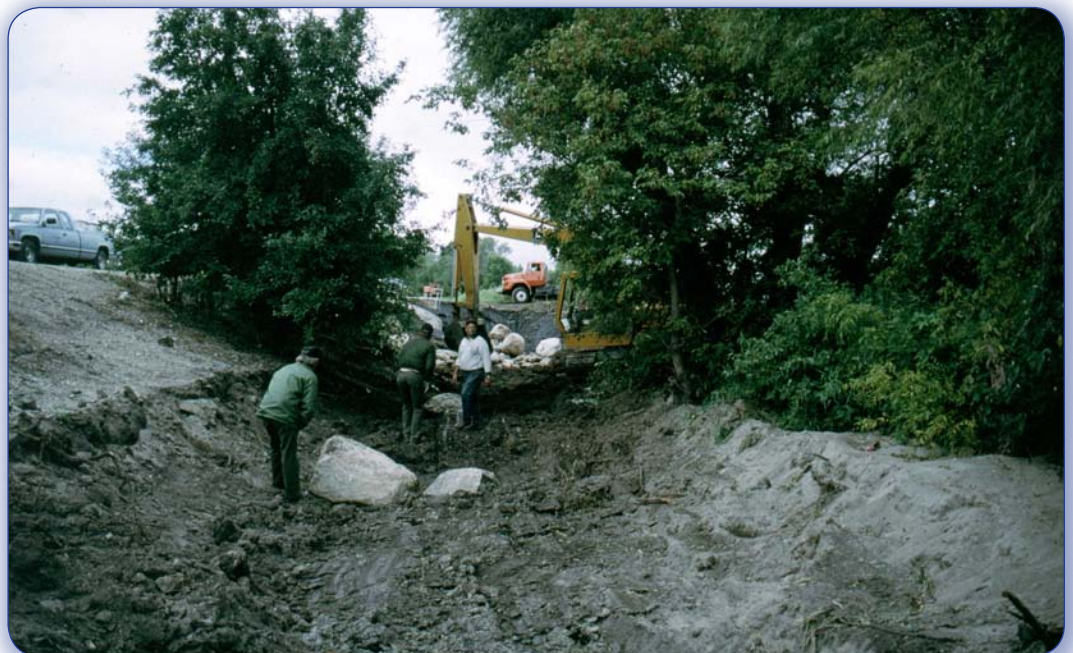
Figure 83. Construction of the Breckenridge Fishway channel showing placement of the boulder weirs.

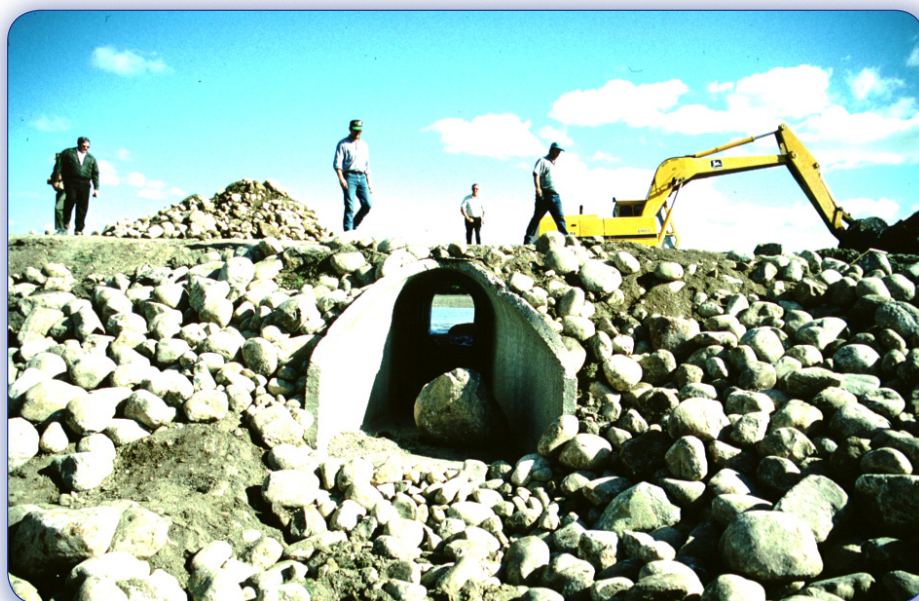
Figure 84. Placement of the culvert for the Breckenridge Fishway.

Once the channel was completed, culvert sections were excavated into the dam embankment and placed successively from the downstream end. Two to three-foot boulders were placed inside the culvert as each section was laid (Figure 84). The embankment had a wooden sheetpile core that was cut to fit tightly around the culvert section. A clay cofferdam was built to allow placement of the final culvert section. The entire culvert was wrapped with geotextile fabric to prevent leakage. Clay was packed around the culvert and both ends were armored with fieldstone. The cofferdam was removed and flow was allowed to enter the fishway.

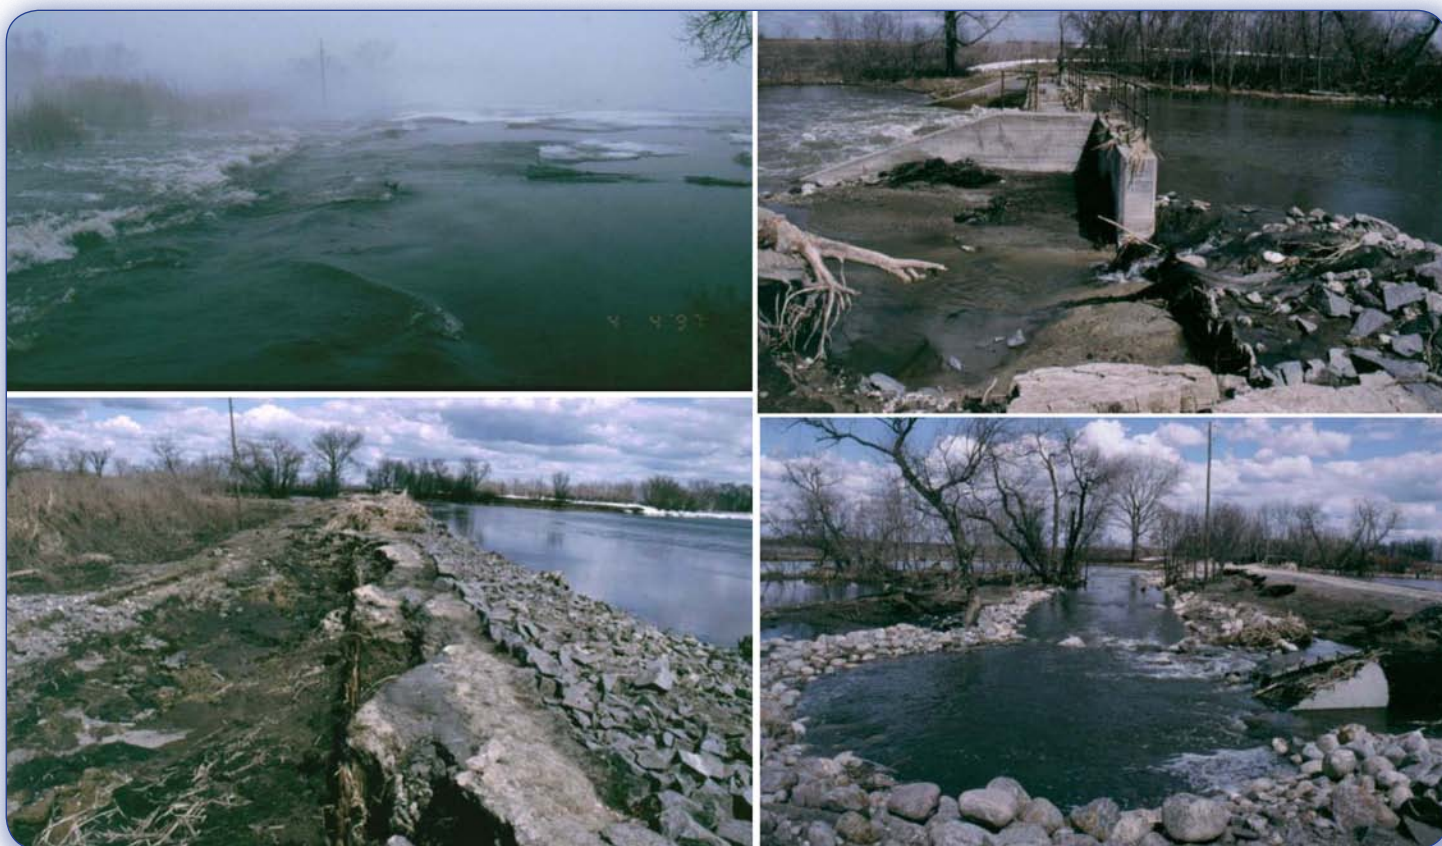
Figure 85. The 1997 flood and damage to the Breckenridge Dam.
