Nature-like Fishways

RECONNECTING RIVERS

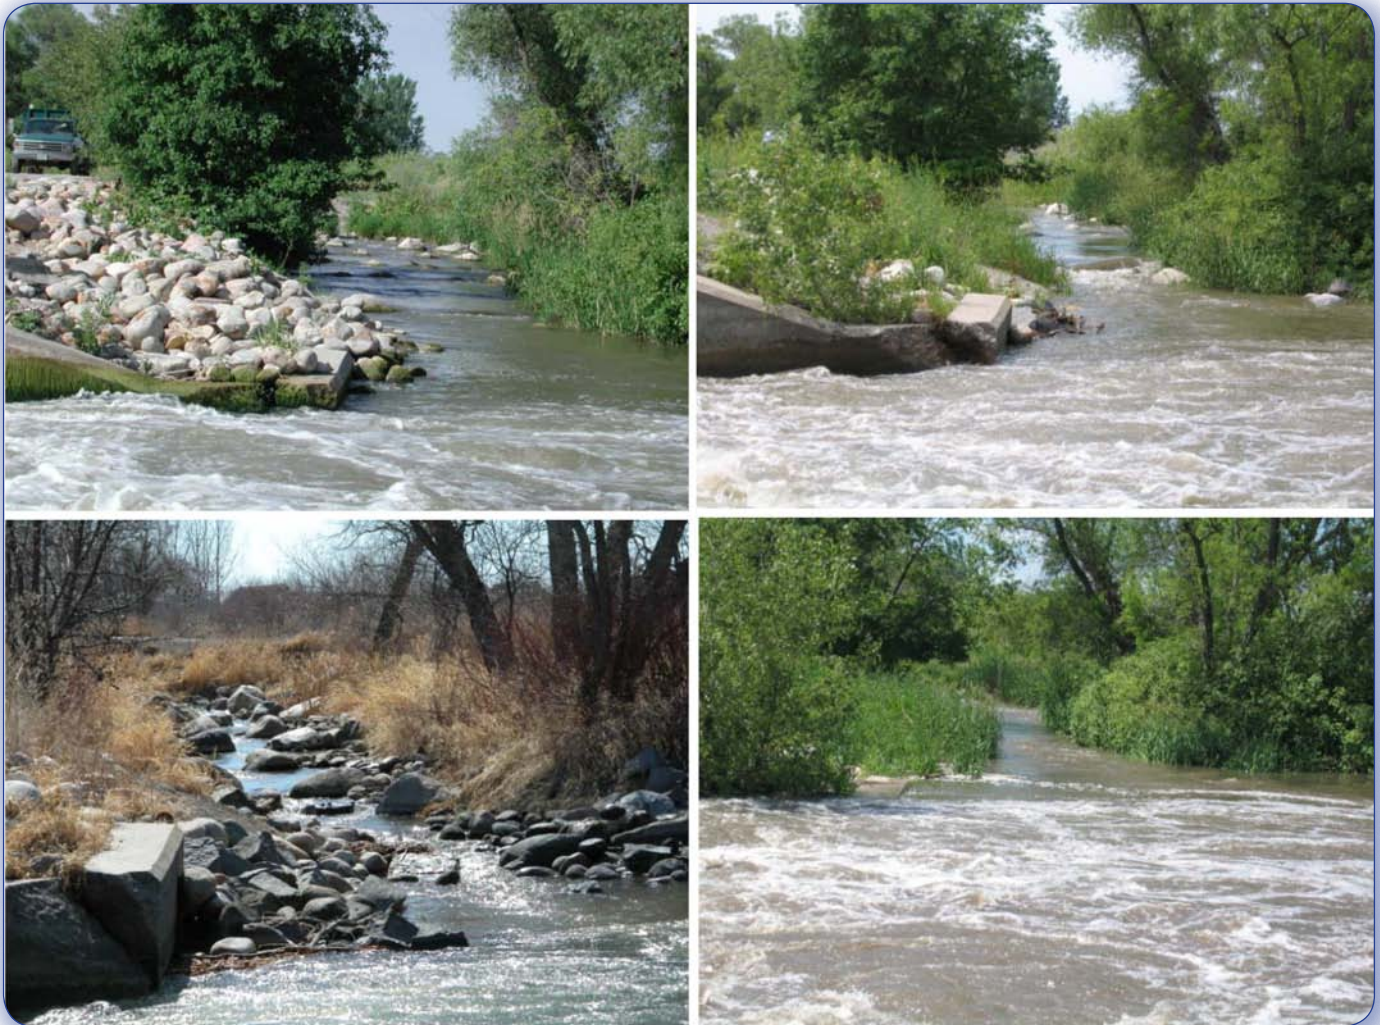
Figure 86. Breckenridge Fishway during a range of river flows and reservoir levels.

The fishway has performed as designed and has been passable over a wide range of river flows and reservoir elevations (Figure 86). Flow in the fishway is a function of reservoir levels while high river flows raise tailwater elevations and inundate the downstream portion of the fishway. Since the dam has limited spillway

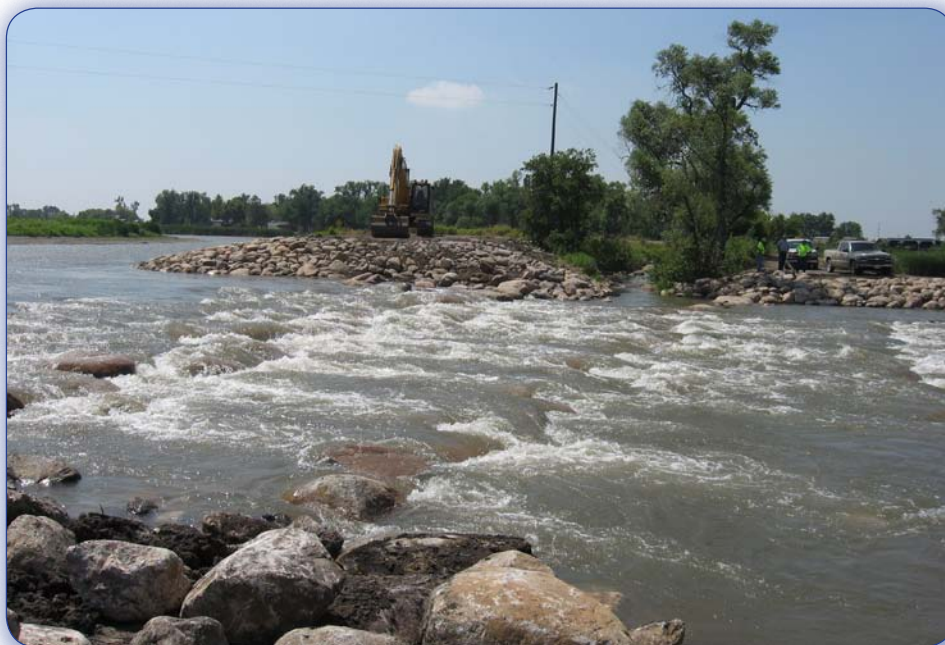
Figure 91. Rapids replacing Breckenridge Dam to provide grade control and facilitate fish and canoe passage. The photo on the top shows the entrance of the by-pass fishway that was left in place. The bottom photo is a view from downstream showing the pool retained in the middle of the rapids.

head loss. A deep pool, popular with local fishermen was preserved in the middle of the rapids by building the last two weirs in a riffle downstream of the pool (Figure 91). This also reduced the amount of base material needed.

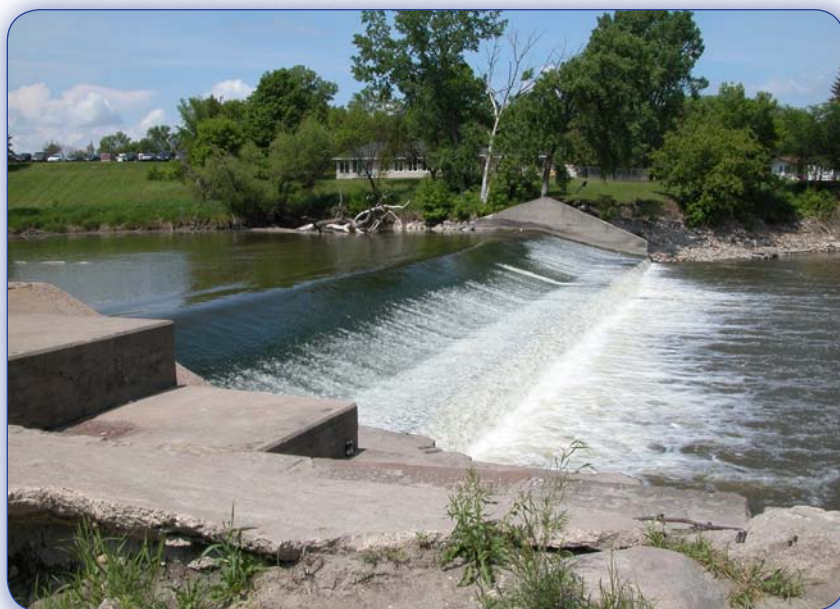
Figure 92. Photo of Crookston Dam showing the footings of the former powerhouse in the foreground.

The Crookston Dam was originally built in 1883, apparently as a milldam. The dam was a rock filled timber crib structure that was later capped with concrete (Figure 92). It was converted to hydropower in 1905 and retired in 1970. The powerhouse had two turbines rated at 176 and 200 KW. The 176 KW turbine was retired in the late 1950s with the 200 KW turbine retired in 1970 (Terry Graumann, Otter Tail Power, personal communications). A number of similar sized hydropower dams in Minnesota have been retired due to low power production and high dam maintenance costs.

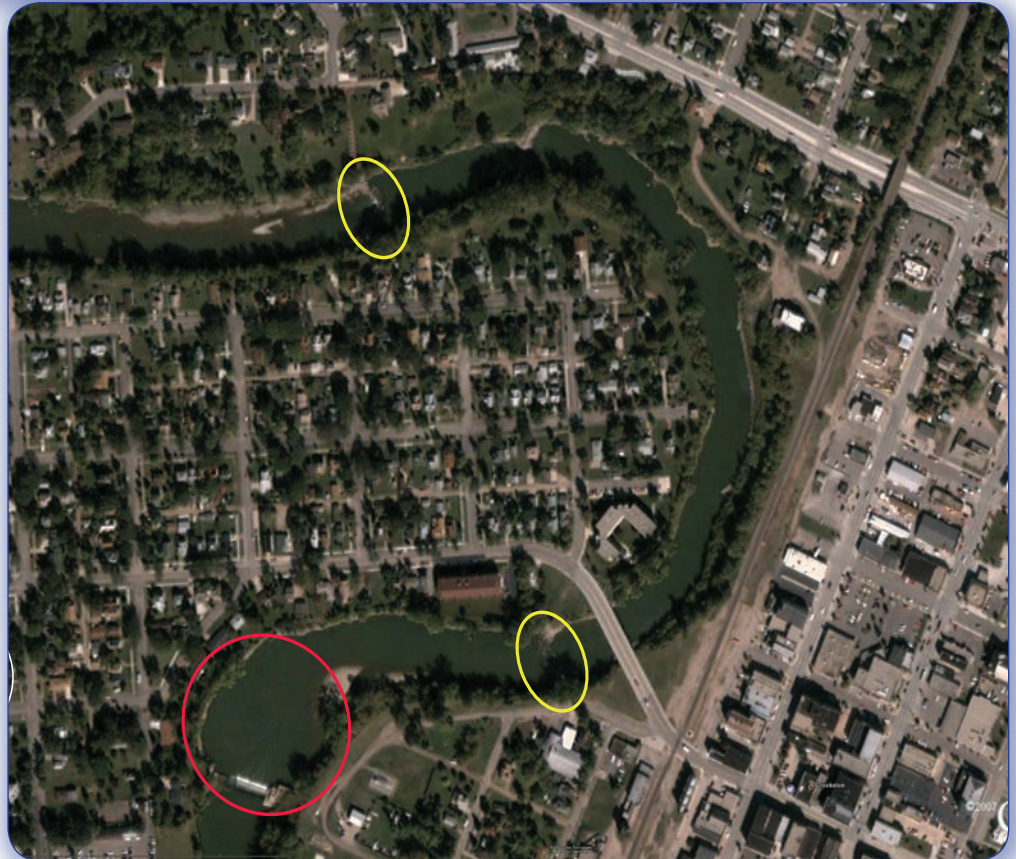
Figure 94. Aerial photo of the Crookston Dam showing downstream tailwater erosion (red circle) and riffles (yellow ovals) built to protect against further bed degradation and to raise minimum tail-water elevation.

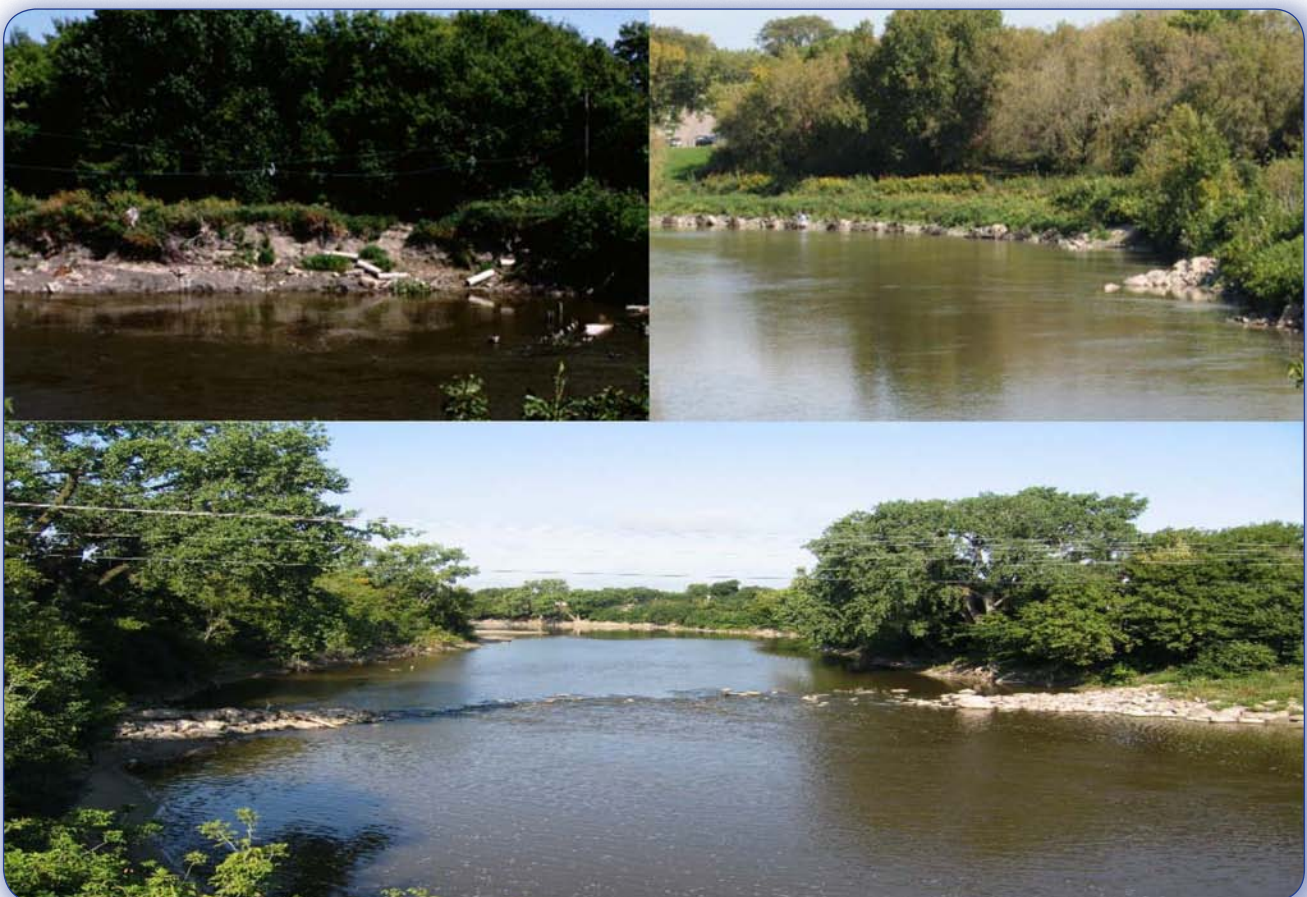
Figure 95. Bank failure (upper left) and restoration using rootwads, boulder vanes, native plantings (upper right), and boulder riffles (bottom) downstream of Crookston Dam.

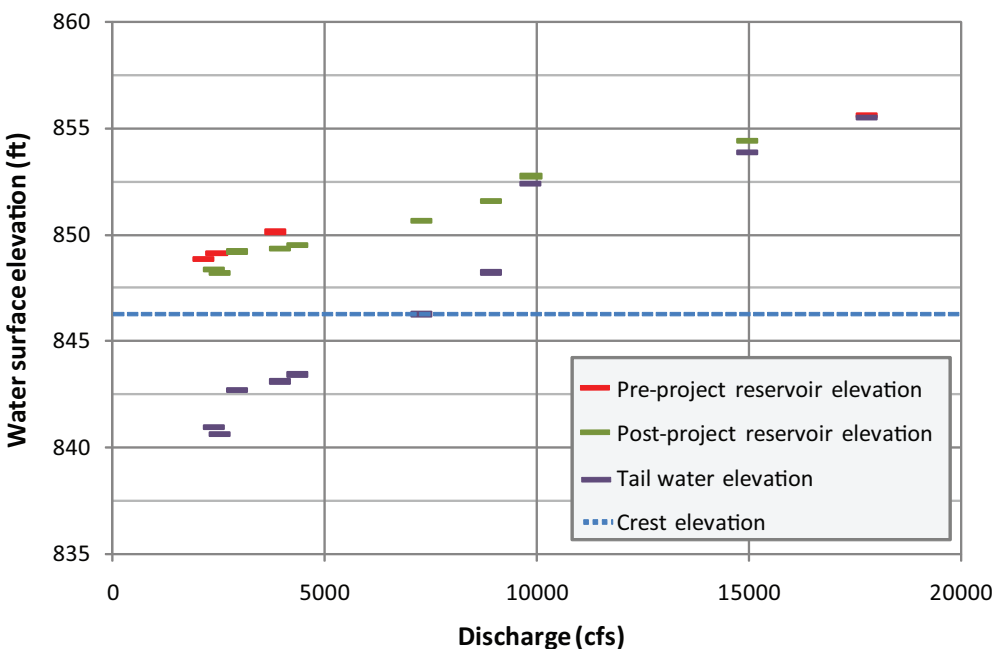
Figure 96. Surveyed headwater and tailwater elevations for the Crookston Dam showing submergence at approximately 18,000 cfs.

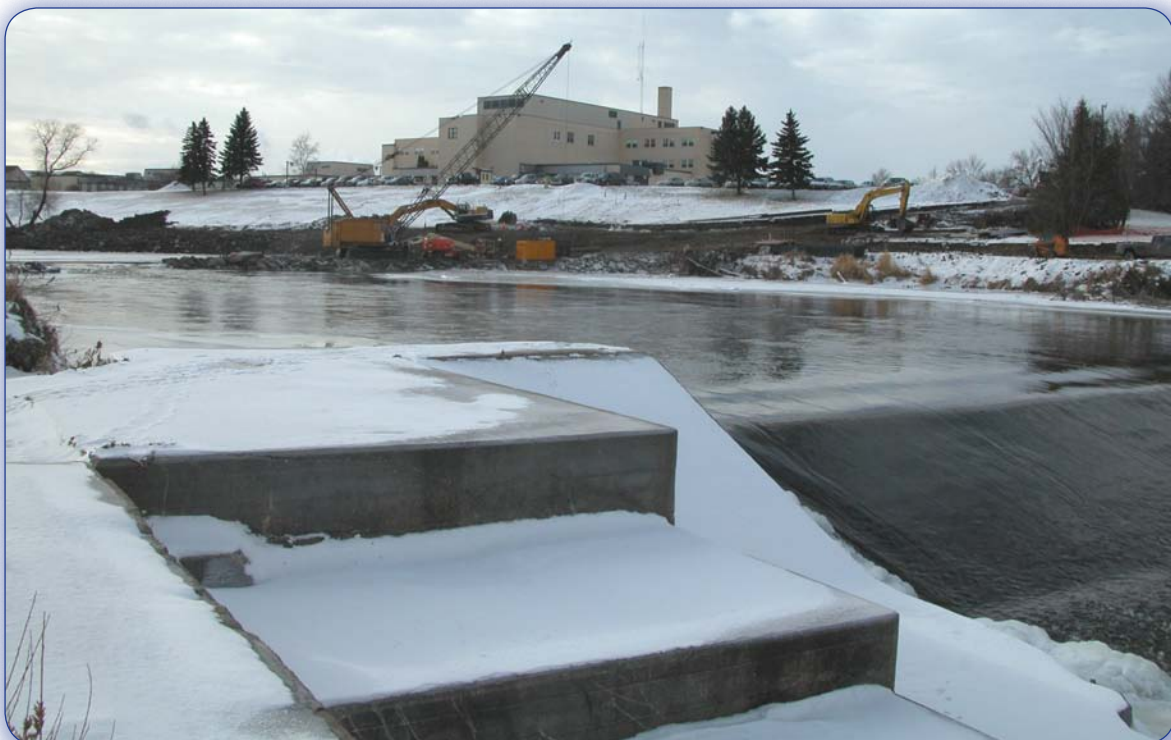
Figure 98. Construction of the rapids crest in the background and the old dam crest in the foreground.

Initial phases of construction (December, 2004) involved bank armoring and installation of the sheet-piling crest. After the new crest was completed, the old dam was demolished (Figure 98).

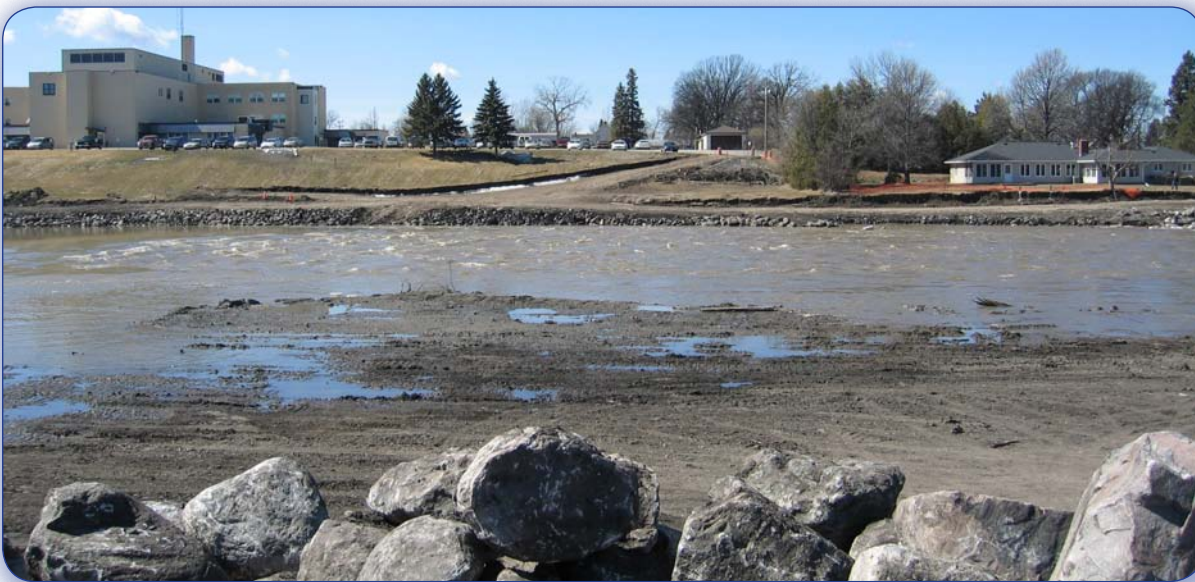
Figure 99. A flood in the spring of 2005 that submerged the partly constructed rapids. The photo was taken on April 1, 2005 at a flow of 9,850 cfs; a peak of 10,100 cfs was reached on April 2.

the dam during construction. This stemmed from concerns that loss of hydrostatic pressure between the existing dam and the new dam crest 300 feet upstream could exacerbate the slump. The slump had moved an estimated 15 feet in two years prior to construction according to the dam safety engineer. Inclinometers showed movement of about 1.5 inches during the five months of construction. The dam base was only partly constructed and was much steeper than design grade when a spring flood submerged the structure (Figure 99). No apparent

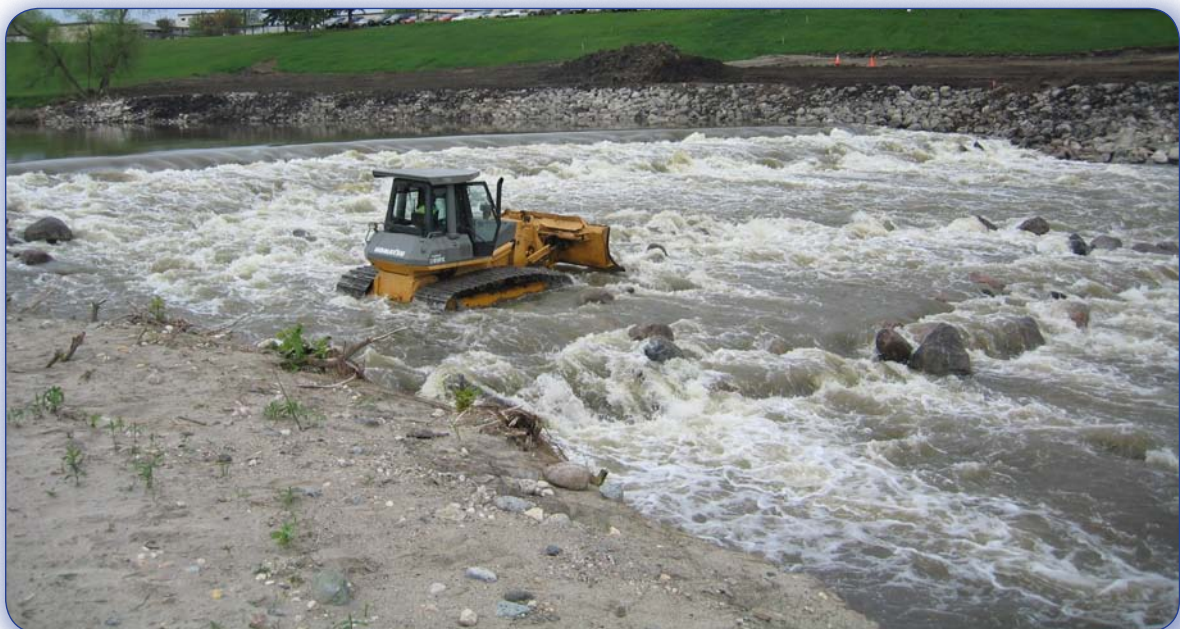
Figure 100. Grading of the fieldstone base with a bulldozer in May, 2005.

The contractor used clean waste concrete as a sub-base covered with three feet of fieldstone base. This worked well as it was angular and inexpensive for the large volume needed. Since it was entirely buried with fieldstone, no waste concrete was exposed. A bulldozer was used to establish the base grade (Figure 100).

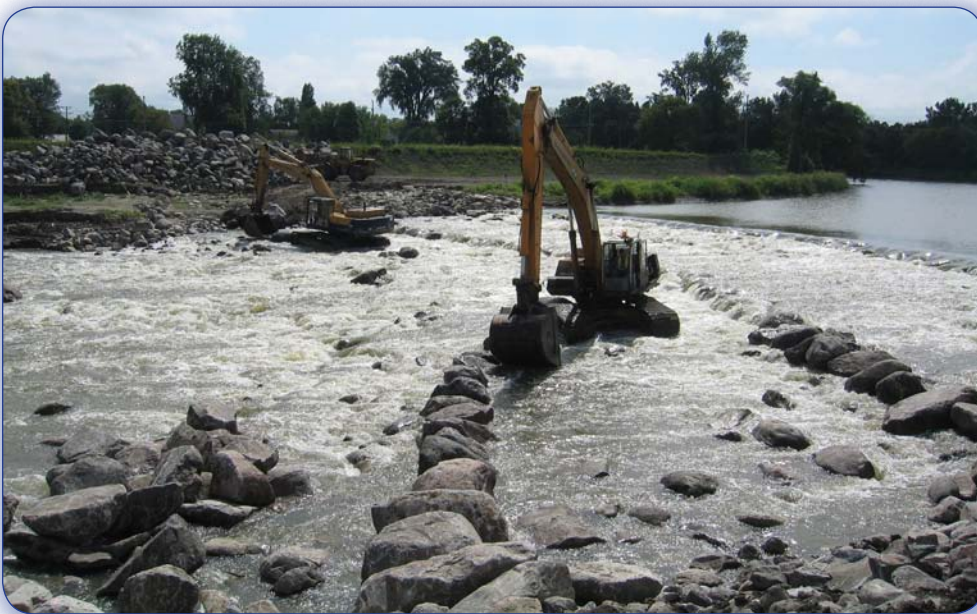
Figure 101. Placement of boulder weirs in the Crookston Rapids.

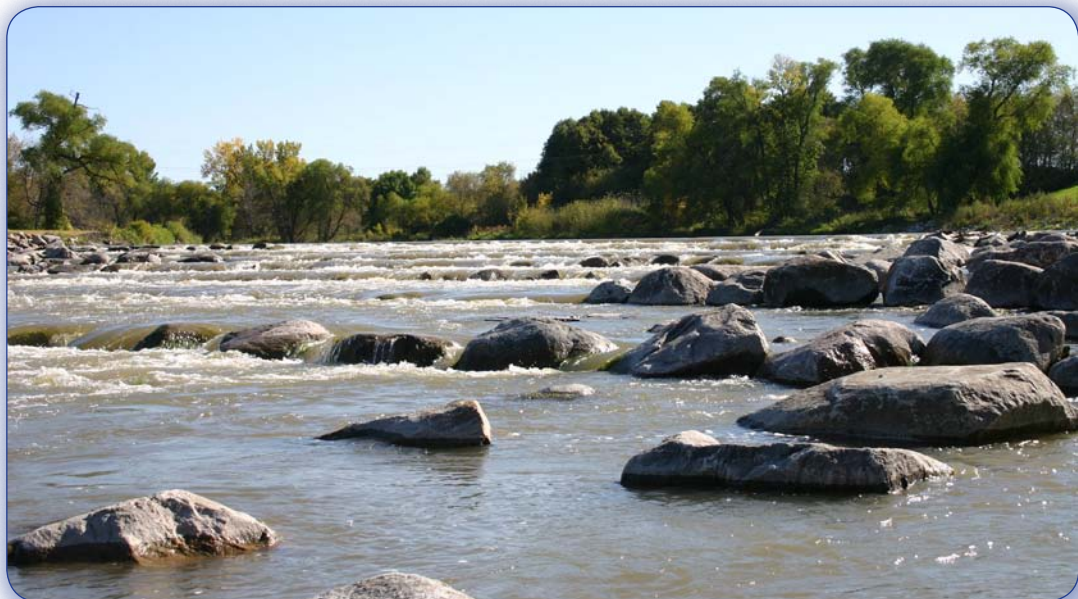
Figure 102. Photo showing completed Crookston Rapids.

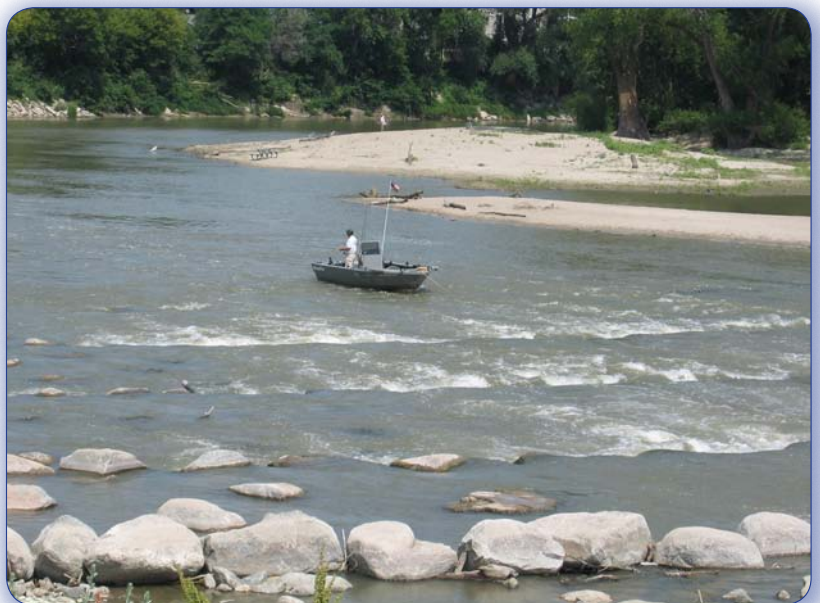
Figure 103. Floodplain deposition along the previously eroded right bank below Crookston Rapids.

As predicted, the rapids design has alleviated the tailwater erosion problems downstream of the original dam site by dissipating energy within the rapids and converging flow vectors. Sediment deposition has created floodplain along the previously eroded right bank while maintaining mid-channel pool depth (Figure 103). A large cottonwood behind this bar was at the water's edge but is now surrounded by a depositional bar at the same elevation as that determined to be bankfull elevation prior to the project's construction. Connected floodplain is rare in this reach of the Red Lake River due to flood control levees on the riverbanks and channel incision.
